# Flightfax

ARMY AVIATION  
RISK-MANAGEMENT  
INFORMATION

APRIL 1999 ♦ VOL 27 ♦ NO 4

## Black Hawk vs. buzzard: it could have been ugly

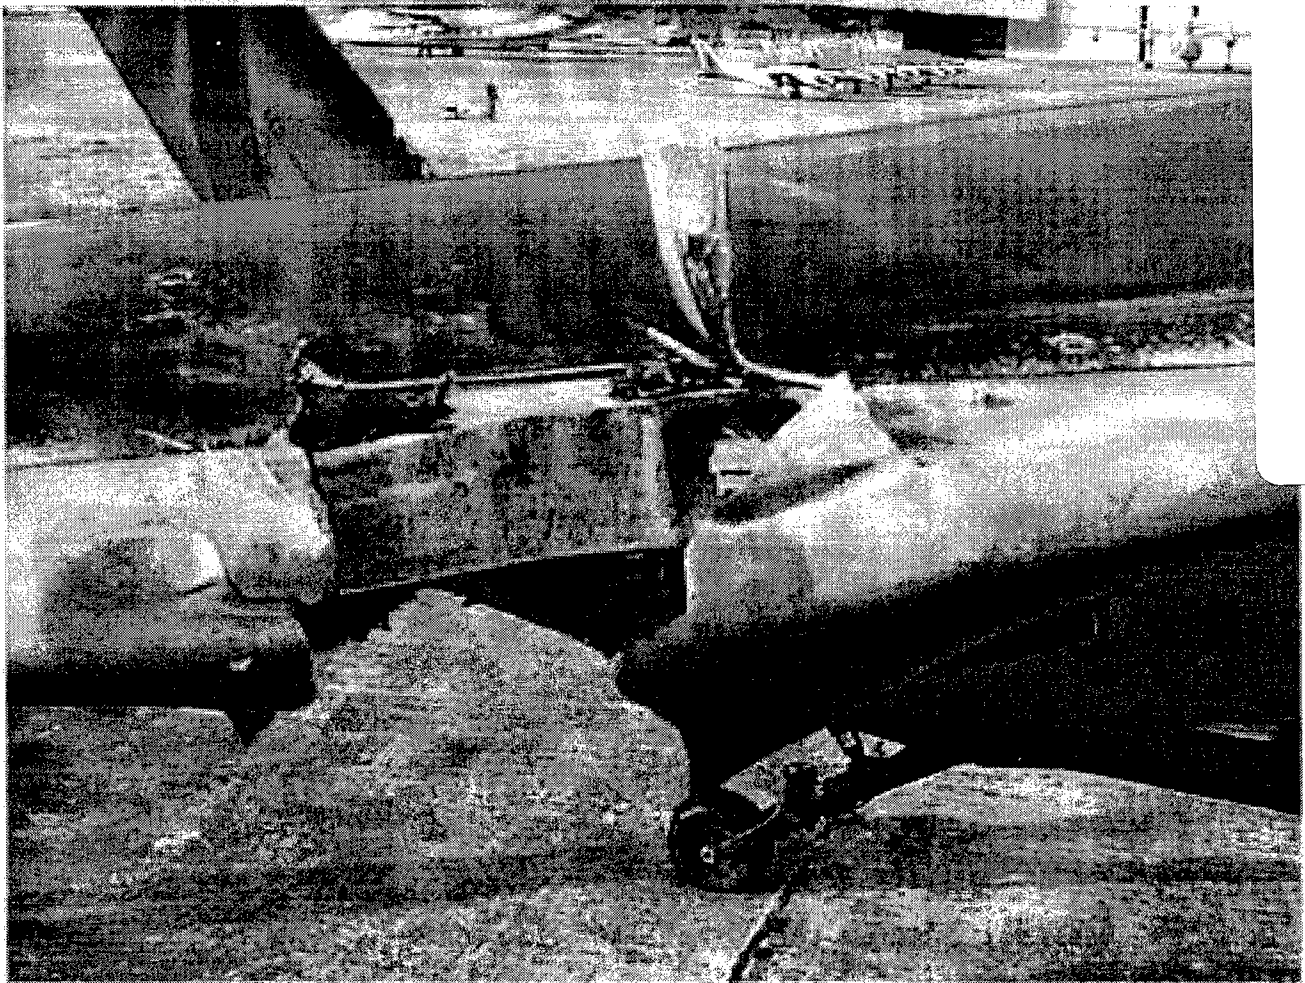
**T**his UH-60 was in the traffic pattern at 700 feet agl and 115 knots when its rotor blade met with a buzzard. The crew had entered a right descending turn in an attempt to miss 5 or 6 birds in the flight path. One bird, however, followed the aircraft into the

turn. The strike was a little like hitting a ripe tomato with a ball bat and sprayed bird over the entire aircraft. When the crew righted the aircraft, they were pointed toward the runway on a modified final at about ½-mile. With no landing area available below, they

continued with a roll-on to the runway and completed an emergency shutdown.

Damage was limited to the blade. And to the bird.
